Army Lodging Wellness Recommendation

Final Submittal - Fort Myer

February 12, 2004

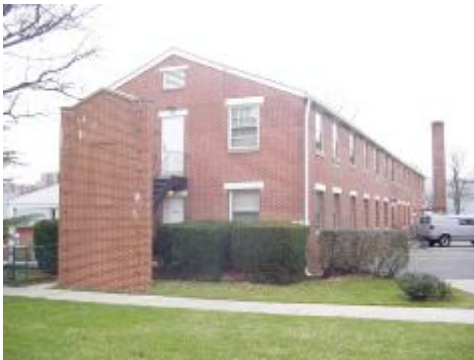
Building 48, constructed in 1944, is a 2-story wood structure housing 13 family suites of varying room size and configuration. This facility does not meet Lodging standards and cannot be reconfigured without significant reconstruction. To renovate Building 48 to the new standards and configuration will exceed 50% of the replacement cost.

It should be noted that this structure may be historic and some Army Lodging functional requirements indicated in the report would require clearance from the SHPO or through Army Alternate Procedures; therefore, some of the requirements may need modification, in which case the prices for implementation may vary from the cost models applied.

Our recommendation is to remove Building 48 from the Lodging inventory, allowing the installation to determine an alternate use for this facility. This facility will be removed from the Fort Myer Wellness Solution and Lodging Master Plan.

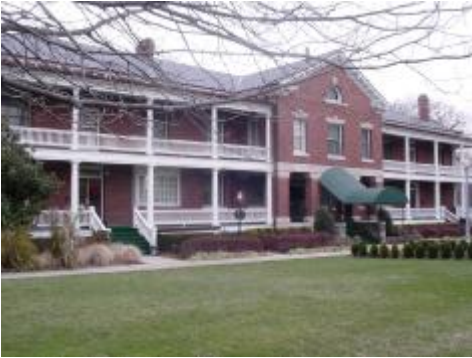
Building 50

Building 50, constructed in 1906, is a 2-story structure, serving as the main Lodging facility at Fort Myer. This facility consists of 18 family suites of varying size and configuration. This facility does not meet Lodging standards and sizes. Although the cost to make condition assessment improvements will slightly exceed the 50% replacement cost, it is our recommendation to remove this facility from the Lodging inventory since the majority of existing room sizes do not meet Lodging standards and reconfiguration to meet the standards will require significant effort and cost.
